Manhole Inspection Summary

Manhole # S09MM1018MH

Insp Date: **2/9/08 2:03 PM**

Location Address: **4822 PARK HEIGHTS AVE**

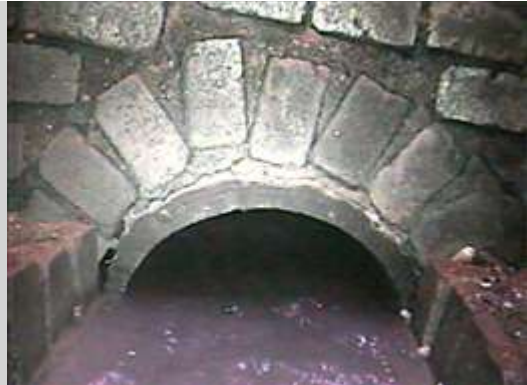
12 O'Clock Outflow

12 in. Circular Gravity Sewer
Pipe Out @ 12 O'Clock

Pipe Height: (in.) Direct
Pipe Material: **Clay** ☐ Pipe Lined
Invert Depth: **10.64** (ft.) Flow Characteristics: **Fast**
Deposits: ☒ None ☐ Mud ☐ Sludge ☐ Debris ☐ Grease
Silt Depth: (in.) Deposits Extent:
Infiltration: **None** Pipe Seal Cond: **Sound**

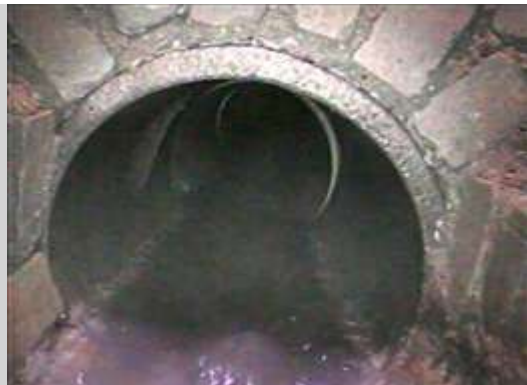
6 O'Clock Inflow

12 in. Circular Gravity Sewer
Pipe In @ 6 O'Clock

Pipe Height: (in.) Direct
Pipe Material: **Clay** ☐ Pipe Lined
Invert Depth: **10.54** (ft.) Flow Characteristics: **Fast**
Deposits: ☒ None ☐ Mud ☐ Sludge ☐ Debris ☐ Grease
Silt Depth: (in.) Deposits Extent:
Infiltration: **Evidence** Pipe Seal Cond: **Sound**
